COULD THIS HAPPEN ON YOUR PLANT?

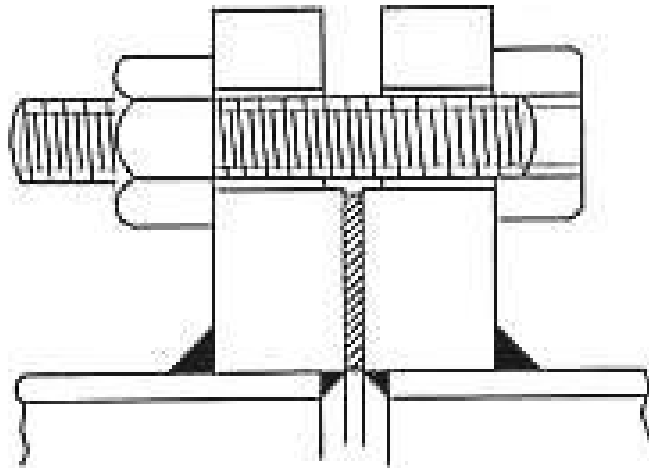
When a plant came back on line after a long shutdown it was found that some of the flanges had been secured with stud bolts and nuts instead of ordinary bolts and nuts, and that some of the stud bolts were located so that there was more protruding on one side than on the other. In some cases one of the nuts was secured by only two or three threads.

Nobody knew why this had been done. Probably one nut was tighter than the other and, in attempting to tighten this nut, the whole stud was screwed through the second nut. Whatever the reason it produced a dangerous situation as the pressure on different parts of the flange was not the same. The plant contained a liquid similar to gasoline in its properties, at a pressure of about 10 bar (150 psig) and a temperature of about 150°C (300°F), much the same as the plant at Flixborough where a leak exploded in 1974, killing 28 people.

Stud bolts should not be indiscriminately mixed with ordinary bolts or used in their place, as they are often made of different grades of steel and produce a different tension.

On the plant concerned, the eight-bolt joints the bolts were changed one bolt at a time. Four-bolt joints were secured with clamps until the next shutdown.
